INDOOR AIR QUALITY ASSESSMENT

**Hastings Elementary School
111 East Main Street
Westborough, Massachusetts**

Prepared by:
Massachusetts Department of Public Health
Bureau of Environmental Health Assessment
March, 2002

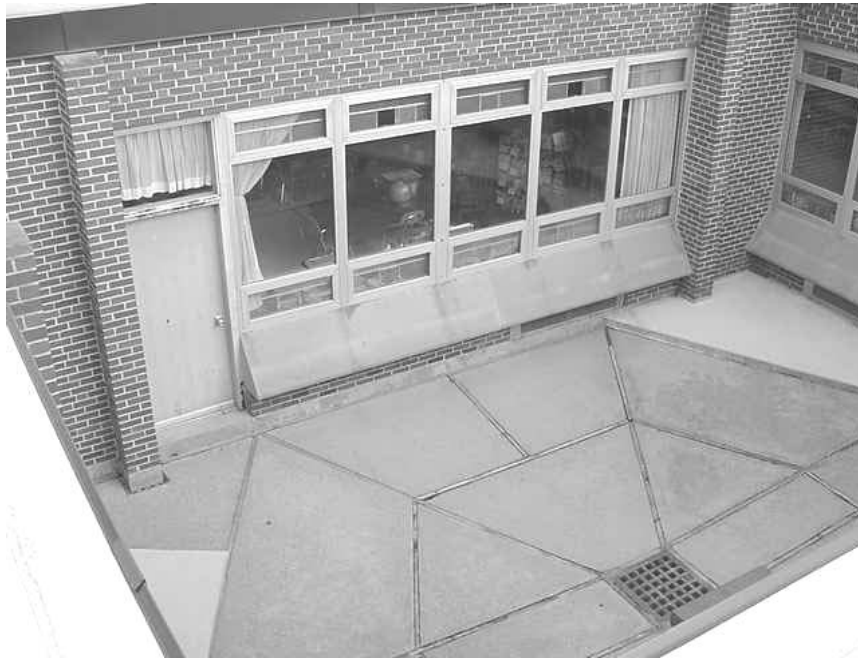
Picture 1

The pod courtyards were also paved with concrete (see Picture 1). EH&E conducted a follow-up study at the HES on December 20, 1999. Filters in univents were found to be short. The HES was found to be positively pressurized. Carbon dioxide

Pod Courtyards Were Paved With Concrete

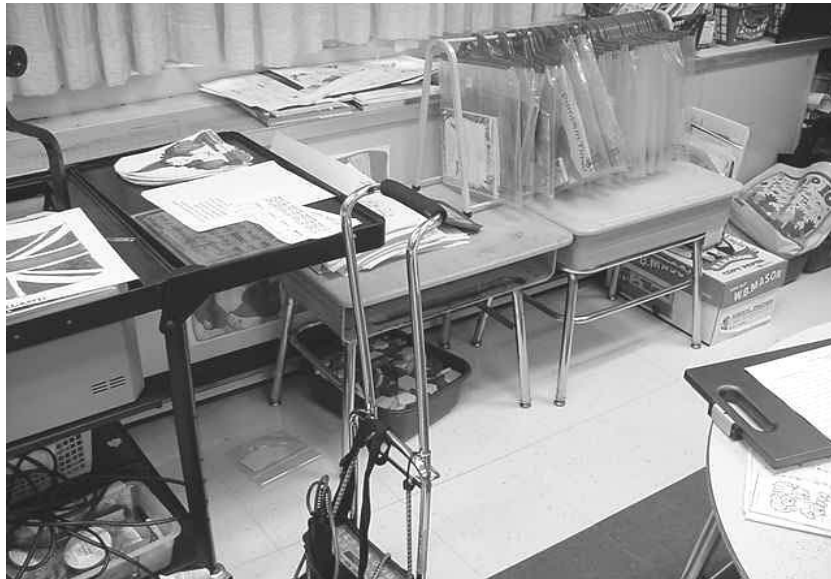
Picture 2

Univent Blocked With Desks and Paper

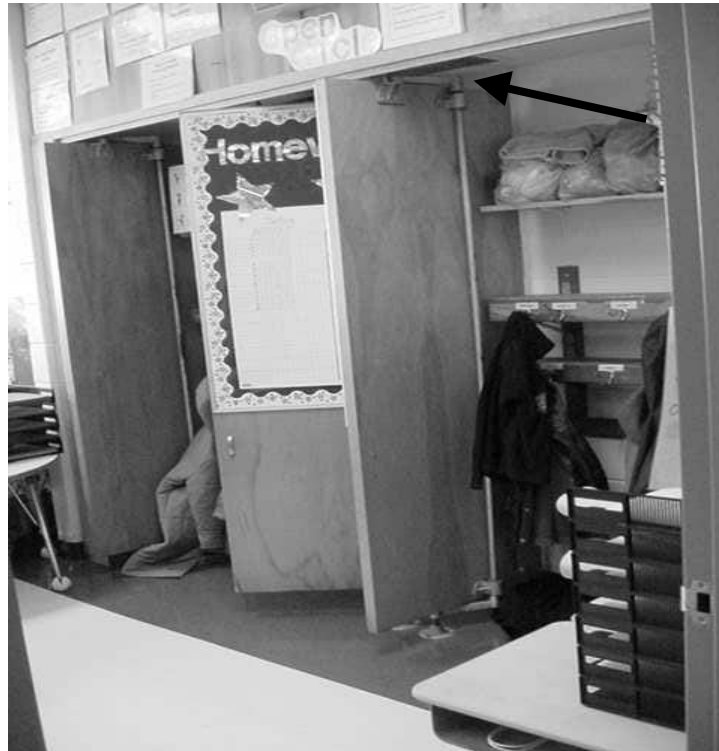
Picture 3

Exhaust ventilation is provided by a ducted system, with the return grille located in the ceiling of the coat closets in each classroom (see Picture 3). Classroom air is drawn into the coat closet from the classroom via undercut closet doors. These vents were designed to remove moisture/odors from the closets. This exhaust system was operational, but a weak draw of air was noted in a number of rooms. It was reported by school officials that exhaust capabilities were reduced to prevent the negative pressurization of classrooms, which has been a well-documented problem in the past (EH&E, 1999a; CEC, 1999a; HIAQD, 1991). The location of these closet vents also allows them to be easily blocked by stored materials. In order to function properly, these vents must remain free of obstructions.

Exhaust Vent in Closet of Classroom

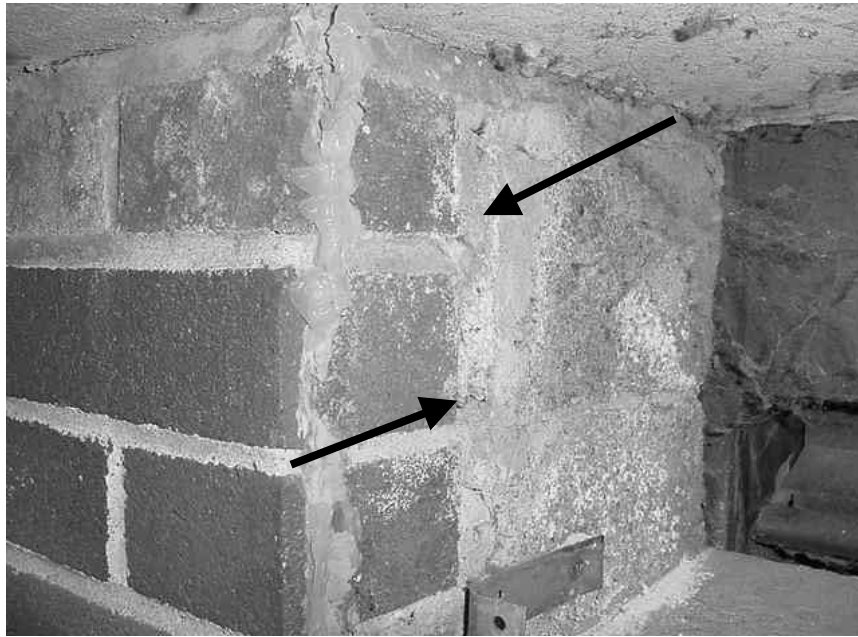
Picture 4

Airspace Between the Exterior Wall and Drainage Plane - Sealed With Concrete

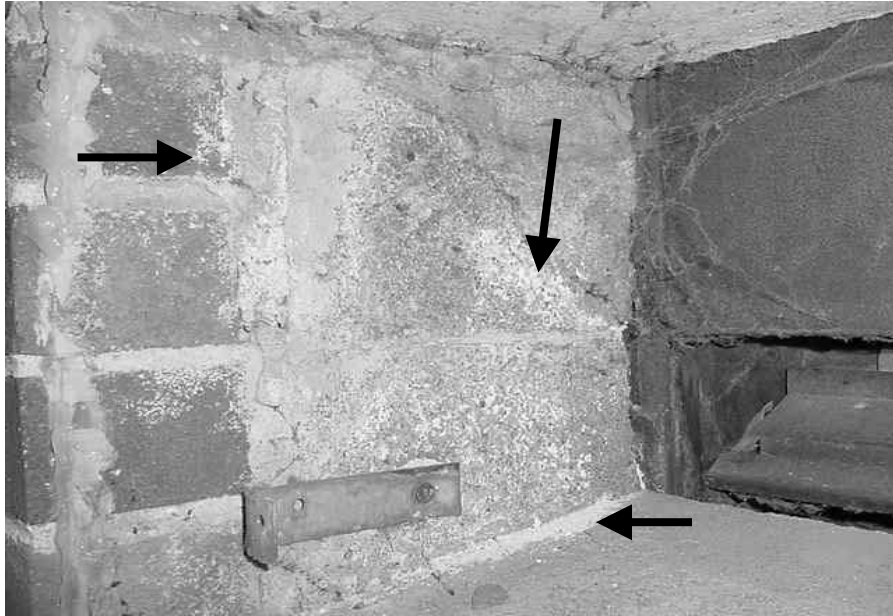
Picture 5

In order to ascertain the condition of the exterior wall system, the fresh air intake grill for a univent was removed to check for the presence of a sheet metal duct connecting the grill to the univent. No such duct existed for this univent. Fresh air is drawn through the grill through the exterior wall to the air intake opening for the univent. No flashing to direct rainwater exists in this intake. The apparent airspace between the exterior wall and drainage plane was sealed with concrete (see Picture 4). The interior wall of brick forming the fresh air intake opening was coated with efflorescence, indicating water penetration (see Picture 5).

The Interior Wall of Brick Forming the Fresh Air Intake Opening Coated with Efflorescence, Indicating Water Penetration

2. In order to remove moisture from curtain wall/drainage plane system penetrating into the univent fresh air intake hole, it is recommended to install a duct connecting the fresh air intake grill to the base of each univent (see Figure 3). The duct should be constructed of a material that is water/corrosion resistant and is installed in a manner to facilitate moisture drainage and drying of surrounding brickwork.

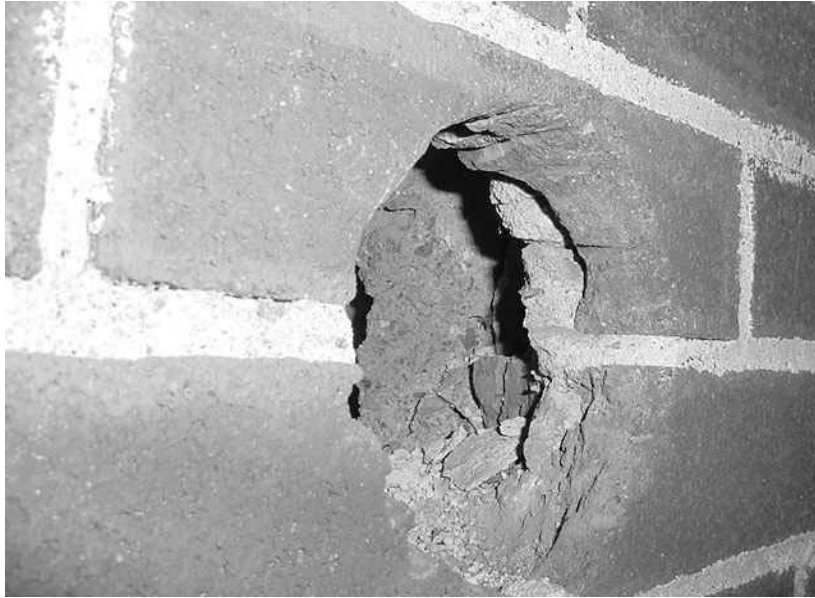
Picture 6

Hole Cut For the Installation of An Exhaust Vent In An Interior Courtyard

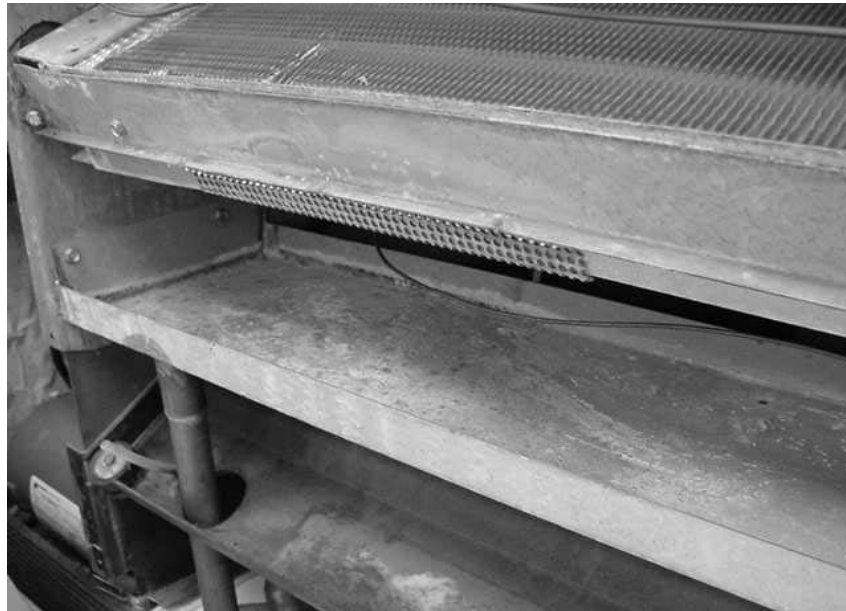
Picture 7

In every univent examined, a characteristic pattern of corrosion (rust) was noted, indicating that water accumulates within each pan (see Picture 7). With the temperature

Corrosion on Surface of Drip Pans

7. Relocate or place tile or rubber matting underneath water cooler(s)/fountains.
8. Remove accumulated scale and corrosion from the surface of drip pans.

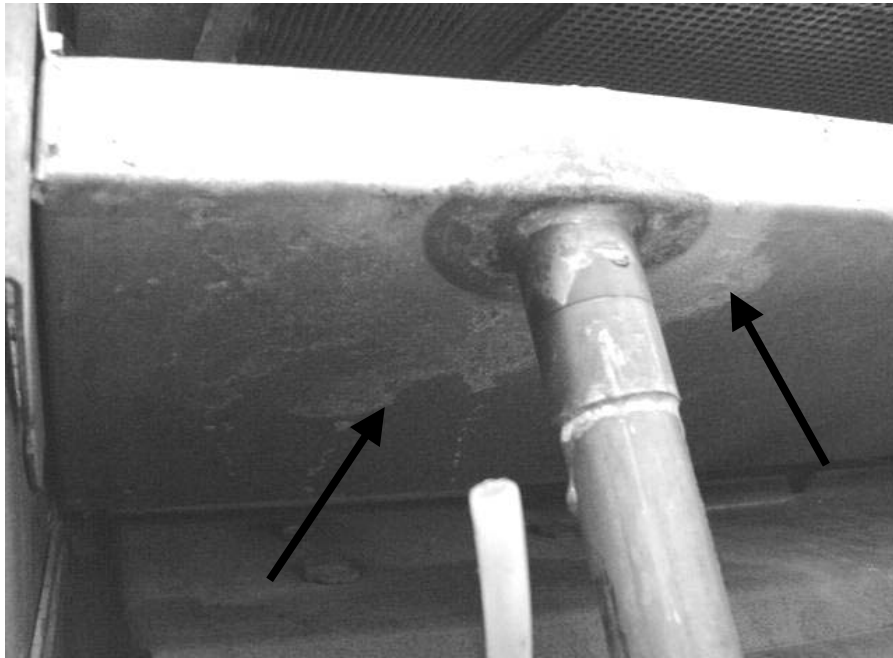
Picture 8

All univents examined lacked insulation. Signs of dried condensation were noted on the underside of drip pans (see Picture 8), inside univent control chambers (see Picture 9) and possible subtle staining of library carpets (see Picture 10) was observed. This condition was also observed in carpeting immediately adjacent to library univents. Accumulated dust in univent control cabinets, univent filters and carpeting may all serve as mold growth media if moistened for extended periods of time. The American Conference of Governmental Industrial Hygienists (ACGIH) recommends that porous materials be dried with fans and heating within 24 hours of becoming wet (ACGIH, 1989). If porous materials are not dried within this time frame, mold growth may occur. Water-damaged, porous materials cannot be adequately cleaned to remove mold growth. The application of a mildewcide to moldy materials is not recommended. In addition, water coolers/fountains were located over/on wall-to-wall carpeting in various areas. Spills or overflow from usage can result in wetting of the carpet, which can lead to mold growth.

Signs of Dried Condensation Noted on the Underside of Drip Pans

5. Insulate the surface of drip pans not in contact with condensation with an appropriate material.
6. If water penetration/efflorescence observed in various areas of the building returns, consideration should be given to having a building engineer examine each damaged area with the intent to recommend possible drainage plane remediation strategies.

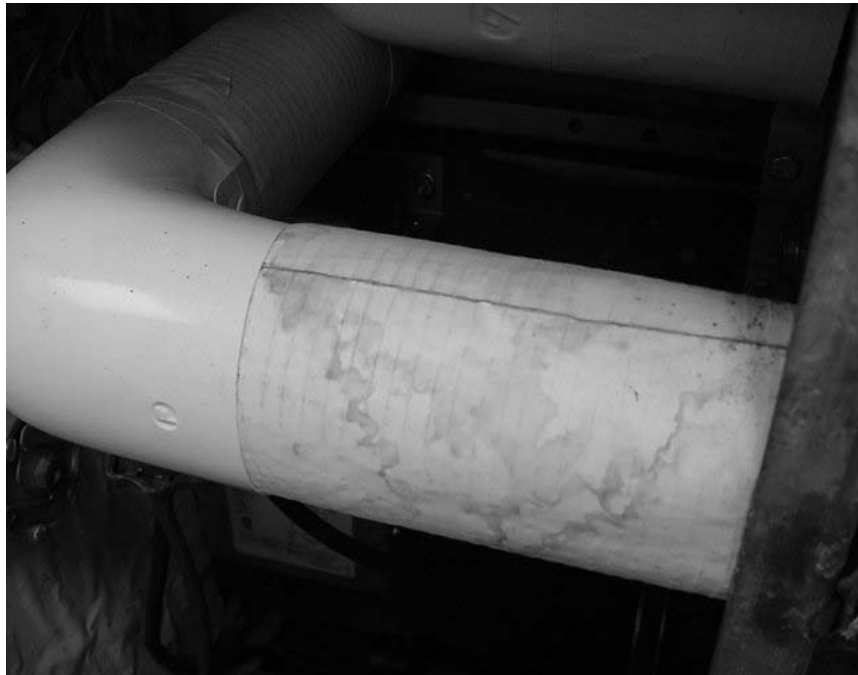
Picture 9

Signs of Dried Condensation on Pipe Insulation inside Univent Control Chambers

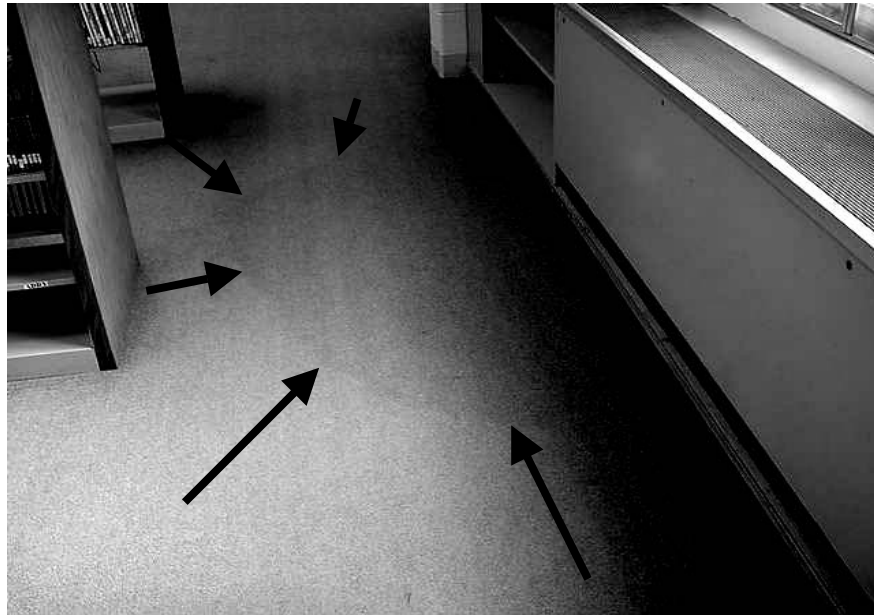
Picture 10

Stain On Library Carpet

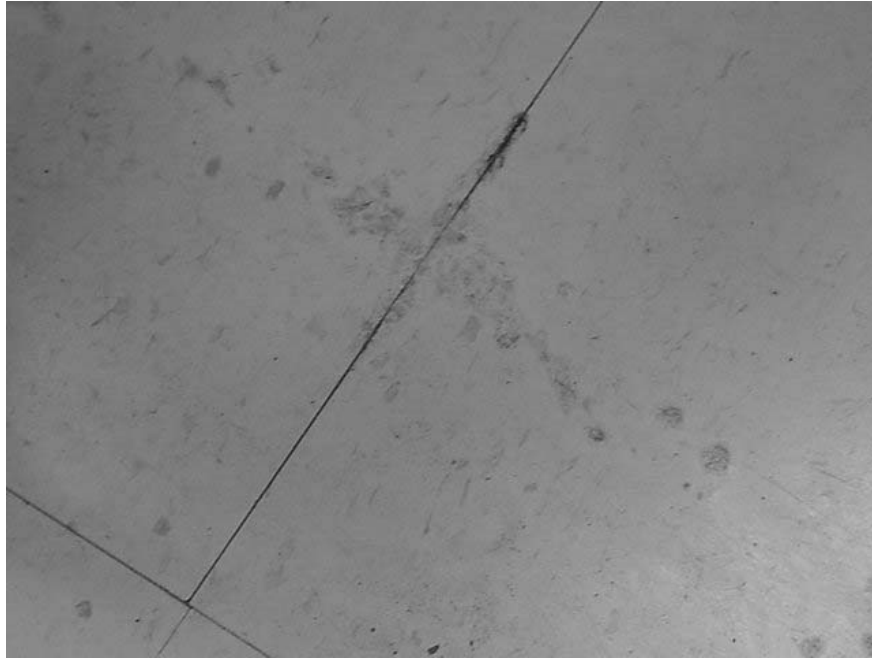
Picture 11

Seeping From Seams in Classroom Floor Tile

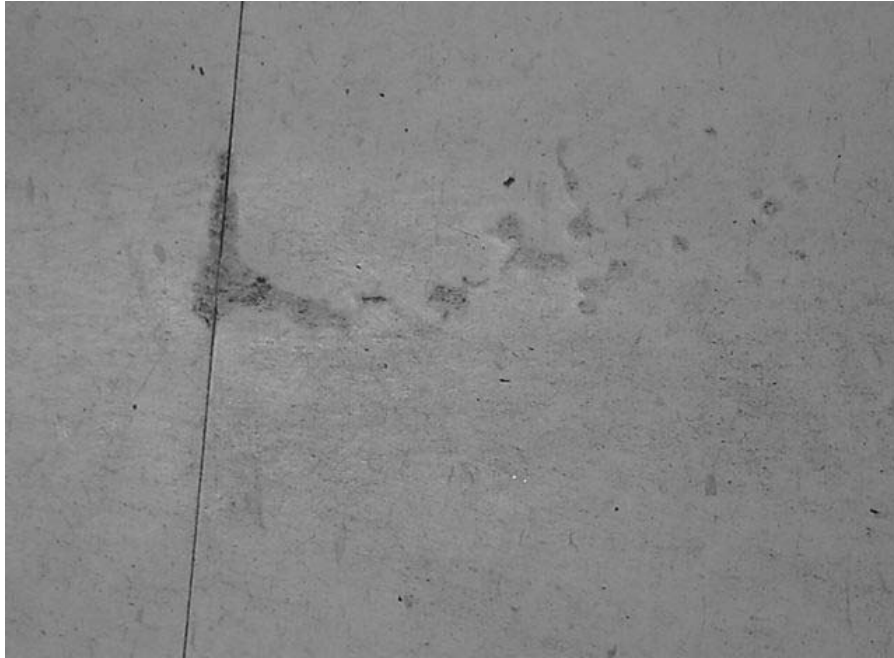
Picture 12

Seeping From Seams in Classroom Floor Tile

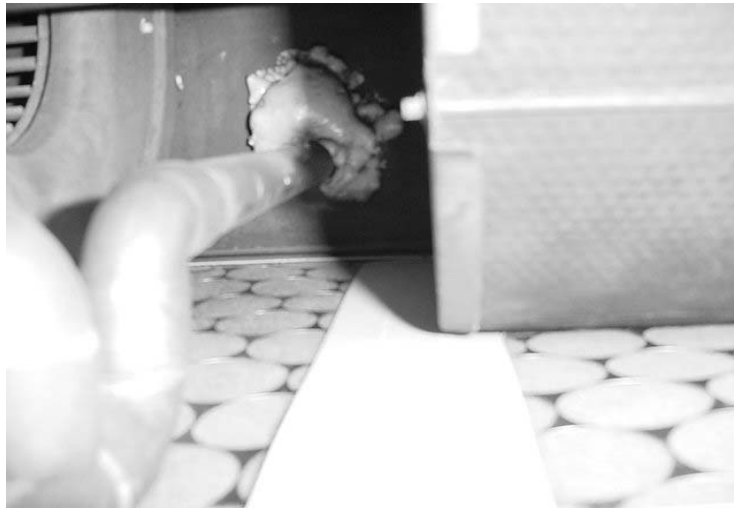
Picture 13

**Univent Condensation Drain Passing Through the Rear Cabinet Wall.
Note that This Drainpipe is above the Filter and below Univent Fans**

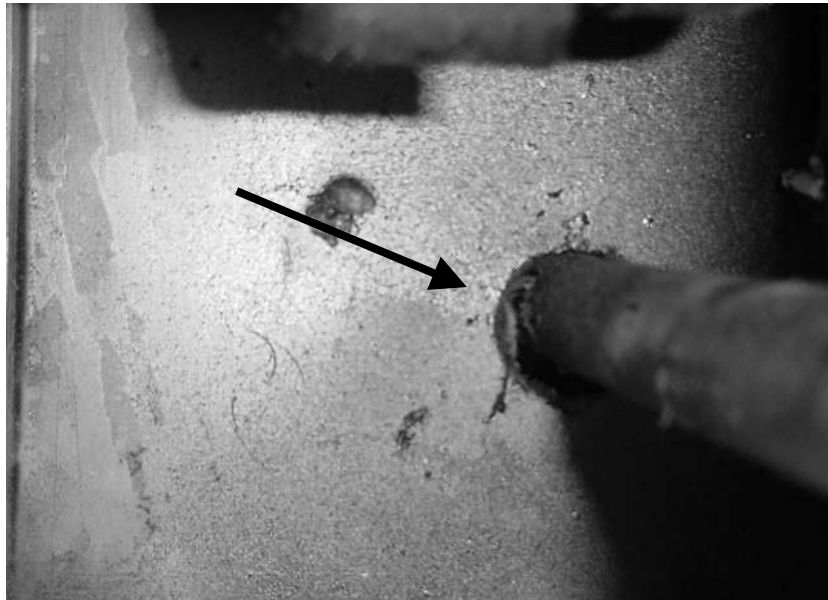
Picture 14

Light From Univent Condensation Drain Cabinet Hole, Indicating an Air Pathway

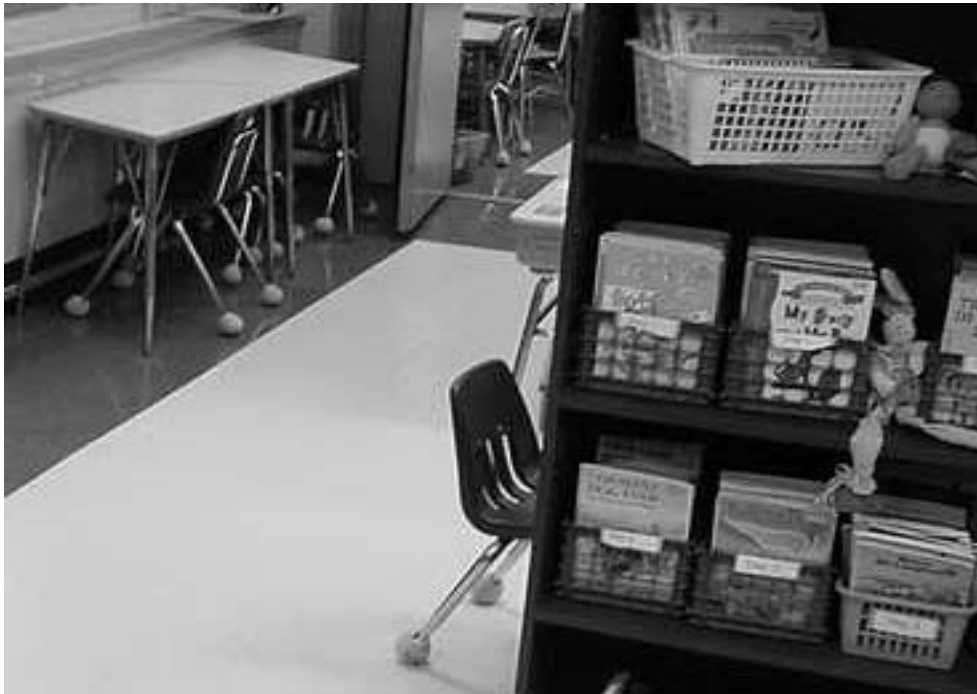
Picture 15

A source of TVOCs, independent of floor tiles however, was identified during the BEHA sampling. In an effort to reduce noise from sliding chairs, tennis balls are sliced open and placed on chair legs (see Picture 15). A newly opened tennis ball had an initial TVOC concentration inside the ball of 15 ppm, which eventually dropped to 4 ppm after several minutes. Tennis balls are made of a number of materials that are a source of respiratory irritants. Constant wearing of tennis balls can produce fibers and to off-gas TVOCs. Tennis balls are made with a natural rubber latex bladder, which becomes abraded when used as a chair leg pad. Use of tennis balls in this manner may introduce latex dust into the school environment. Some individuals are highly allergic to latex (e.g., spina bifida patients) (SBAA, 2001). It is recommended that the use of materials containing latex be limited in buildings to reduce the likelihood of symptoms in sensitive individuals (NIOSH, 1997). A question and answer sheet concerning latex allergy is attached as [Appendix A](#) (NIOSH, 1998).

Tennis Balls Are Sliced Open and Placed on Chair Legs
